## **STREAM MORPHOLOGICAL DESCRIPTION OF THE UMATILLA RIVER**

John D. Williams, Caty F. Clifton,  
and Ron W. Rickman

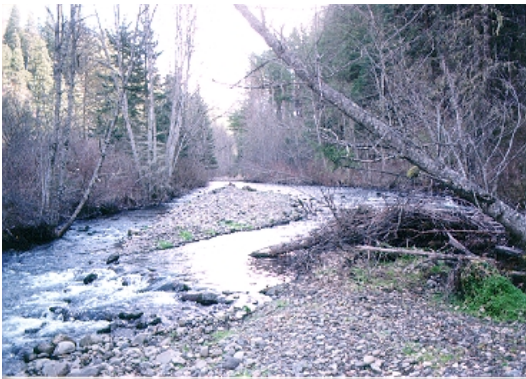
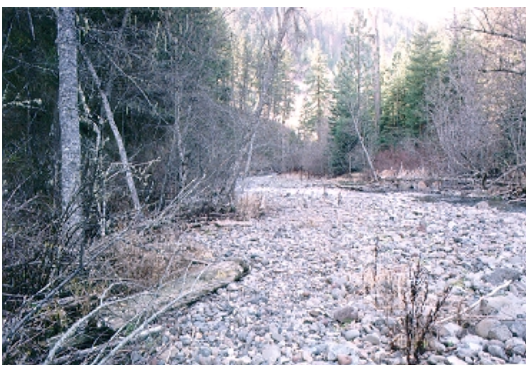
a) Location (RM)	0.5
b) Width	
low flow (ft)	22
high flow (ft)	77
c) Channel material	gravel, cobble, few boulders
d) Sinuosity	medium
e) Wood in channel	no
f) Canopy (degrees)	50
g) Azimuth (degrees)	280
h) Slope (%)	2.5
i) Manning's $n$	0.04
j) Classification	B4

Plate 1a. North Fork, Umatilla River, view upstream, 20 Feb. 1998.

Plate 1b. North Fork, Umatilla River, view downstream, 20 Feb. 1998.

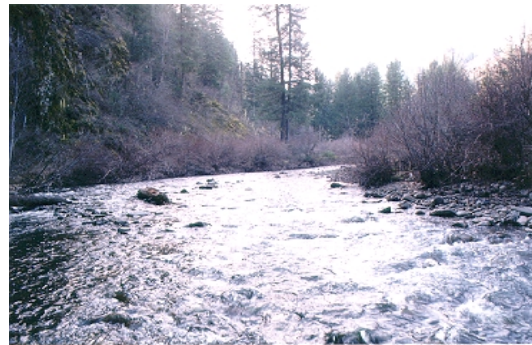
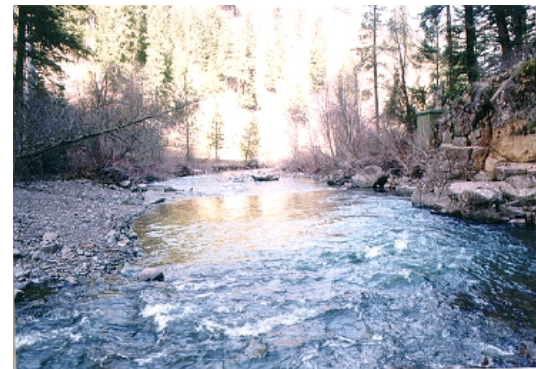
a) Location (RM)	0.9
b) Width	
low flow (ft)	22
high flow (ft)	100
k) Channel material	gravel, cobble, few boulders
c) Sinuosity	medium
d) Wood in channel	no
e) Canopy (degrees)	60
f) Azimuth (degrees)	350
g) Slope (%)	2.5
h) Manning's $n$	0.04
i) Classification	B4

B4 streams are moderately sensitive to disturbance by increased streamflow and/or sediment increases, have a moderate sediment supply, low streambank erosion potential, and moderate influence by vegetation on width/depth ratio-stability (Rosgen 1994).

Plate 2a. South Fork, Umatilla River, view upstream, 20 Feb. 1998.

Plate 2b. South Fork, Umatilla River, view downstream, 20 Feb. 1998.

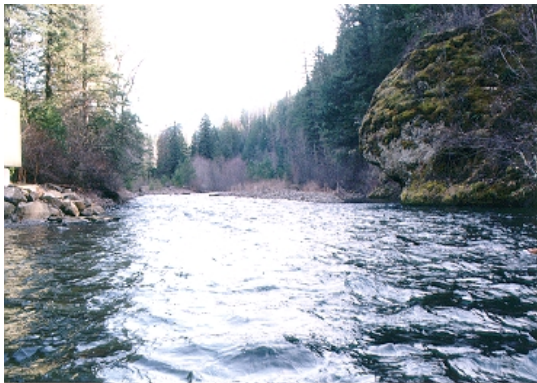
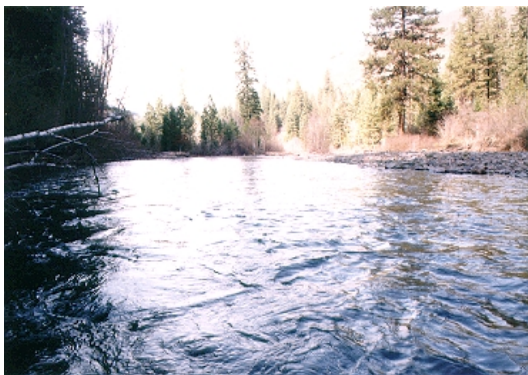
a) Location (RM)	83.1
b) Width	
low flow (ft)	32
high flow (ft)	67
l) Channel material	gravel, cobble, and boulders
c) Sinuosity	medium
d) Wood in channel	yes
e) Canopy (degrees)	90
f) Azimuth (degrees)	332
g) Slope (%)	0.5
h) Manning's $n$	0.035
i) Classification	B4c

The 'c' in the B4c classification represents a decrease in stream slope compared to the North or South Forks of the Umatilla. The description given for the North and South Forks also applies to this site.

Plate 3a. Umatilla River at Corporation, OR, view upstream, 20 Feb. 1998.

Plate 3b. Umatilla River at Corporation, OR, view downstream, 20 Feb. 1998.

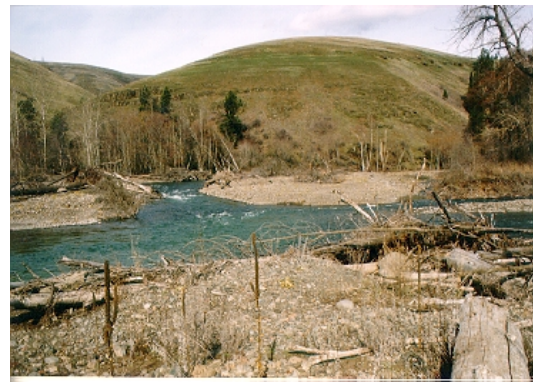
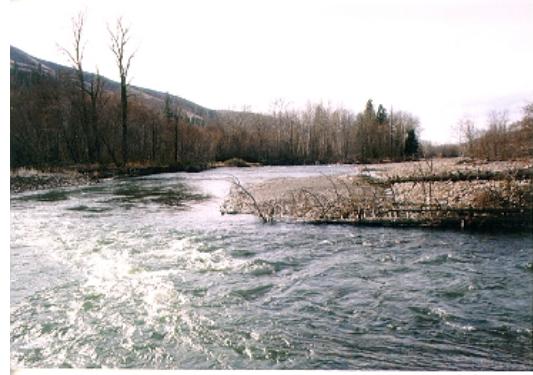
a) Location (RM)	81
b) Width	
low flow (ft)	40
high flow (ft)	260
m) Channel material	gravel, cobble, and boulders
c) Sinuosity	medium
d) Wood in channel	yes
e) Canopy (degrees)	120
f) Azimuth (degrees)	270
g) Slope (%)	1.0
h) Manning's $n$	0.035
i) Classification	C4

C4 streams have very high sensitivity to disturbance, are subject to high sediment loads, have very high potential for streambank erosion, and are very highly influenced by vegetation on width/depth ratio-stability (Rosgen, 1994).

Plate 4a. Umatilla River at Meachum Creek, OR, view upstream, 20 Feb. 1998.

Plate 4b. Umatilla River at Meachum Creek, OR, view downstream, 20 Feb. 1998.

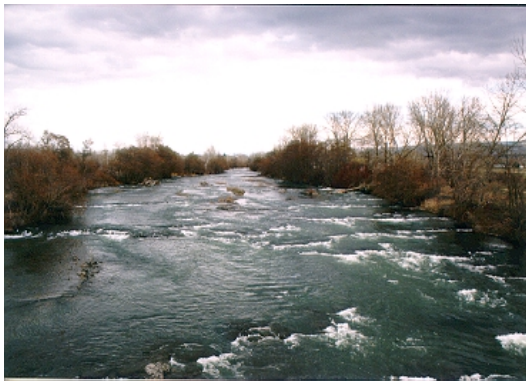
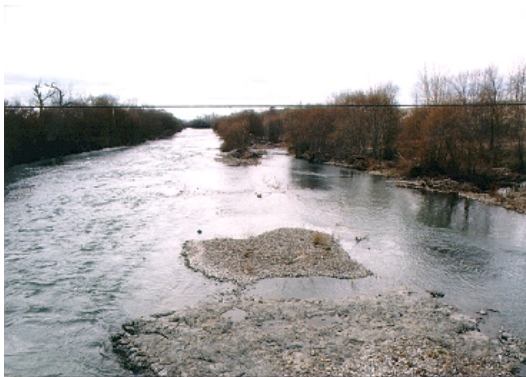
a) Location (RM)	61.5
b) Width	
low flow (ft)	197
high flow (ft)	260
c) Channel material	basalt
d) Sinuosity	low
e) Wood in channel	no
f) Canopy (degrees)	150
g) Azimuth (degrees)	280
h) Slope (%)	1.5
i) Manning's $n$	0.015
j) Classification	B1c

B1 stream sensitivity to disturbance is very low and subject to very low sediment loads, have very low streambank erosion potential, and are negligibly influenced by vegetation on width/depth ratio-stability (Rosgen, 1994).

Plate 5a. Umatilla River at Mission Bridge, OR view upstream, 20 Feb. 1998.

Plate 5b. Umatilla River at Mission Bridge, OR, view downstream, 20 Feb. 1998.

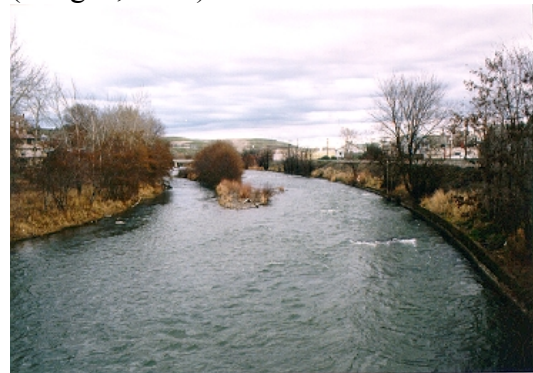
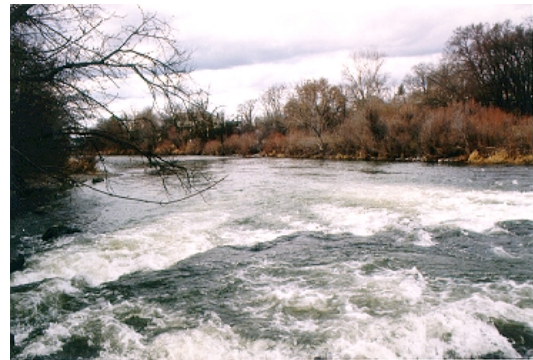
a) Location (RM)	55.0
b) Width	
low flow (ft)	92
high flow (ft)	133
c) Channel material	basalt
d) Sinuosity	low
e) Wood in channel	no
f) Canopy (degrees)	150
g) Azimuth (degrees)	260
h) Slope (%)	1.5
i) Manning's $n$	0.02
j) Classification	F1

F1 stream sensitivity to disturbance is low and subject to low sediment loads, have moderate streambank erosion potential, and are little influenced by vegetation on width/depth ratio-stability (Rosgen, 1994).

Plate 6a. Umatilla River at USGS gauge, Pendleton, OR, view upstream, 20 Feb. 1998.

Plate 6b. Umatilla River at USGS gauge Pendleton, OR, view downstream, 20 Feb. 1998.

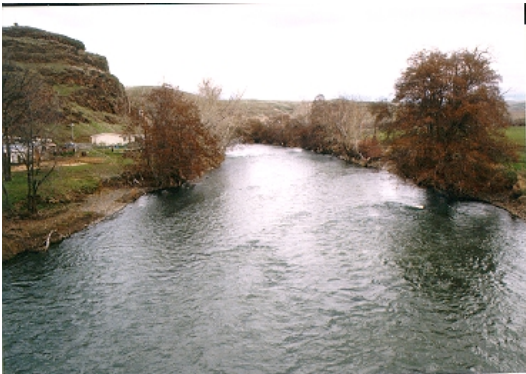
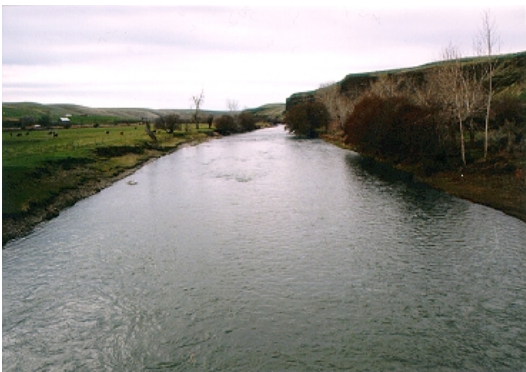
a) Location (RM)	37.8
b) Width	
low flow (ft)	108
high flow (ft)	148
c) Channel material	gravel
d) Sinuosity	low
e) Wood in channel	no
f) Canopy (degrees)	150
g) Azimuth (degrees)	270
h) Slope (%)	1.0
i) Manning's $n$	0.02
j) Classification	F4

F4 streams are extremely sensitive to disturbance by increases in streamflow magnitude and timing or sediment increases, have a very high sediment supply, have very high streambank erosion potential, and are moderately influenced by vegetation (Rosgen, 1994).

Plate 7a. Umatilla River at Yoakum Bridge, OR, view upstream, 20 Feb. 1998.

Plate 7b. Umatilla River at Yoakum Bridge, OR, view upstream, 20 Feb. 1998.

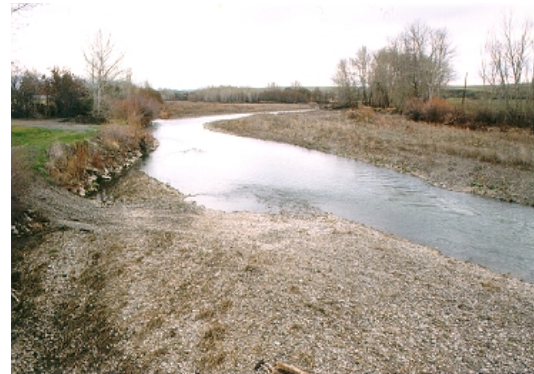
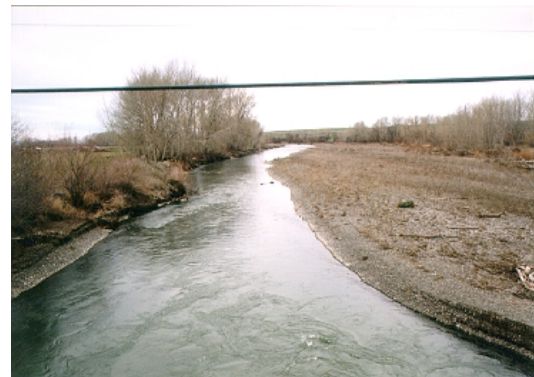
a) Location (RM)	27.0
b) Width	
low flow (ft)	172
high flow (ft)	219
c) Channel material	gravel
d) Sinuosity	low
n) Wood in channel	yes
	(*infrequent, beaver present)
e) Canopy (degrees)	150
f) Azimuth (degrees)	210
g) Slope (%)	1.0
h) Manning's $n$	0.02
i) Classification	F4

Plate 8a. Umatilla River at Echo Bridge, OR, view upstream, 20 Feb. 1998.

Plate 8b. Umatilla River at Echo Bridge, OR, view downstream, 20 Feb. 1998.
